Performance and Durability Evaluation of Bamboo Reinforced Cement Concrete Beams

Abstract— A big part of population in India is still homeless due to raising unaffordability of housing structures. People sleeping on roadsides and living in slums is a common sight in Indian cities. To overcome this problem India today needs millions of houses for their growing population, making concrete as the most widely to be used material in the country. Concrete has found to have excellent compressive strength but poor in tensile strength, to take care of the tensile stresses steel is commonly used as reinforcing material in concrete. Production of steel is a very costly business and its use in concrete as reinforcing material increases the cost of construction by many folds. Also production of steel emits a large amount of green house gases causing considerable deterioration of the environment. The above mentioned socio-economic and environmental factors creates a necessity for finding an appropriate environment friendly and cheap material that can successfully substitute steel as reinforcement in concrete elements of a low cost dwelling for the poor and homeless people of the country. It is

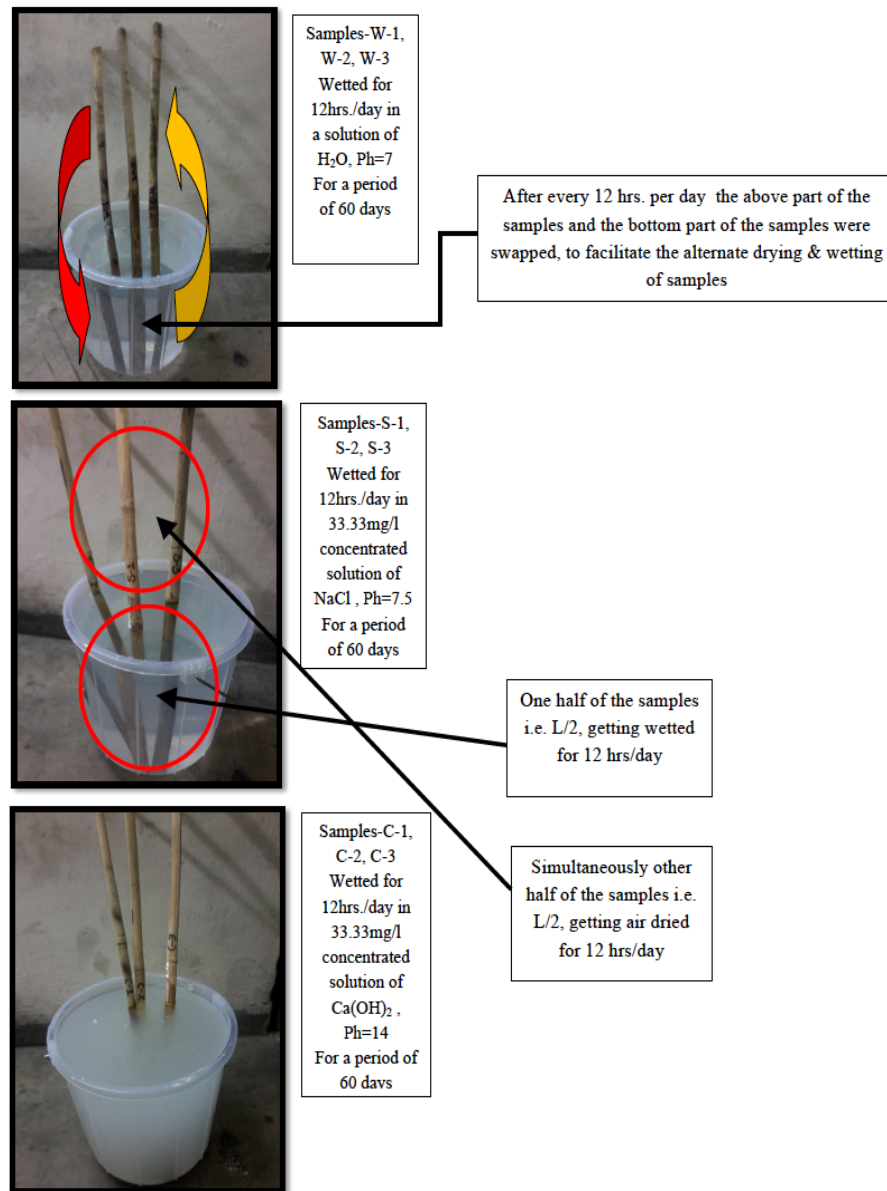
Figure 1: Specimen details and test procedure of durability test.

To check the durability, the samples were subjected to alternate wetting (submerging the specimens in three separate containers one containing plain water other containing NaCl solution and the third containing Ca(OH)₂ solution) and air drying for 12 hours per day continuously for a period of around 60 days at room temperature. After 60 days of undergoing alternate wetting and drying cycles, the samples were taken out from their respective containers and air dried for 24 hours. This is shown in Figure 1.

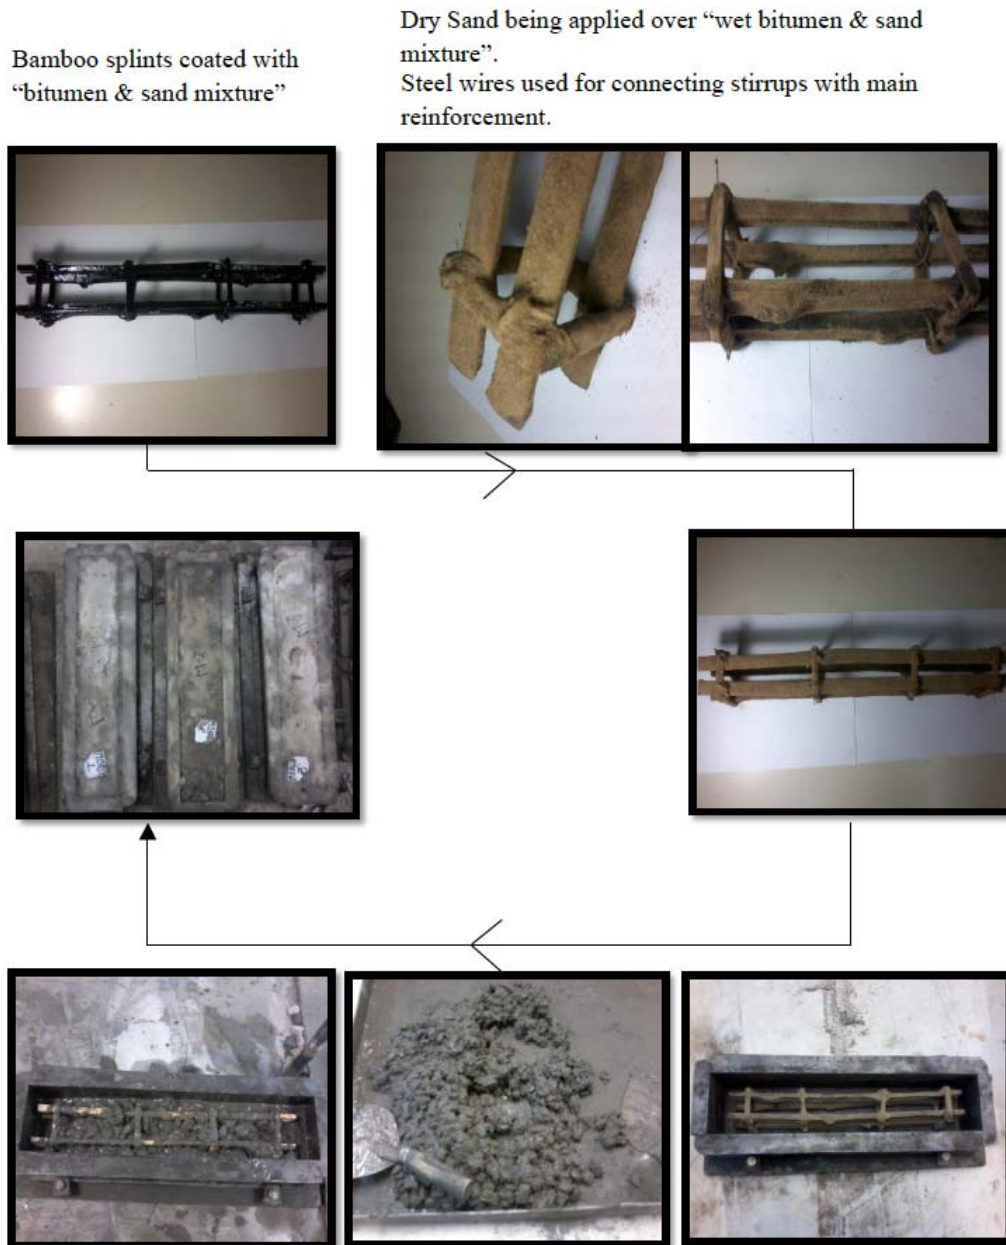
Figure 3: Preparation of MBRCC beam elements (Type - III).

To reduce the water absorption capacity of the bamboo and to improve the bamboo concrete bond strength one part of the samples tested were reinforced with modified bamboo splints i.e. bamboo splints coated with a layer of bitumen and sand mixture (1 part bitumen in 2 parts of sand).

Three different types of total nine cement concrete beams (50cm x 10cm x 10cm) samples were prepared. This included (a) three samples of Plain cement concrete beam (PCC - Type I), (b) Three samples of Bamboo reinforced cement concrete beam (BRCC-Type II) and (c) Three samples of Modified bamboo (bamboo splints coated with bitumen & sand mixture) reinforced cement concrete beam (MBRCC – Type III). The details of the beams have been tabulated and shown in Table 2. Sample preparations for Type II and Type III tests have been shown in Figure 2 and 3 respectively.

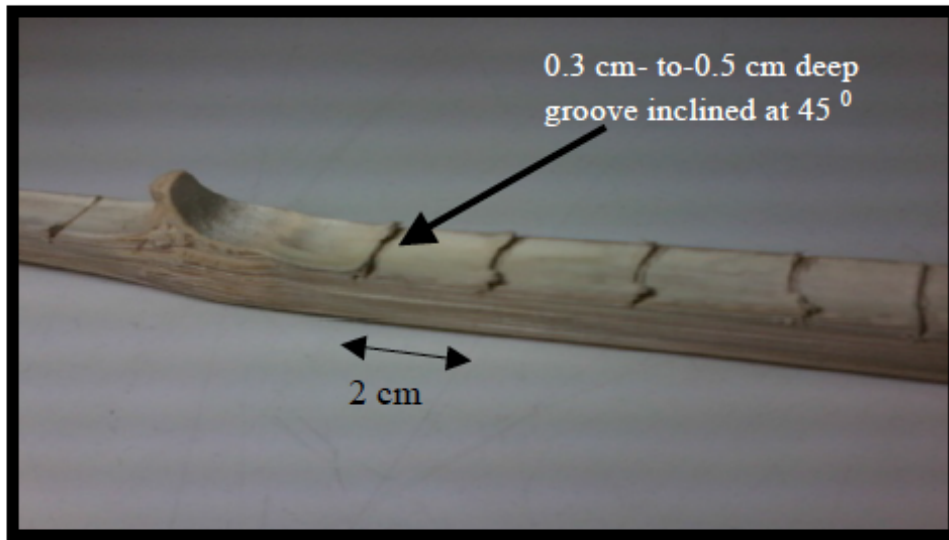
Figure 4: Grooves made for improving bond strength

To improve the bamboo concrete bond strength, 0.3cm-0.5cm deep grooves inclined at 45° were made on the inner part of bamboo stirrups at a spacing of 2 cm. This has been shown in Figure 4.

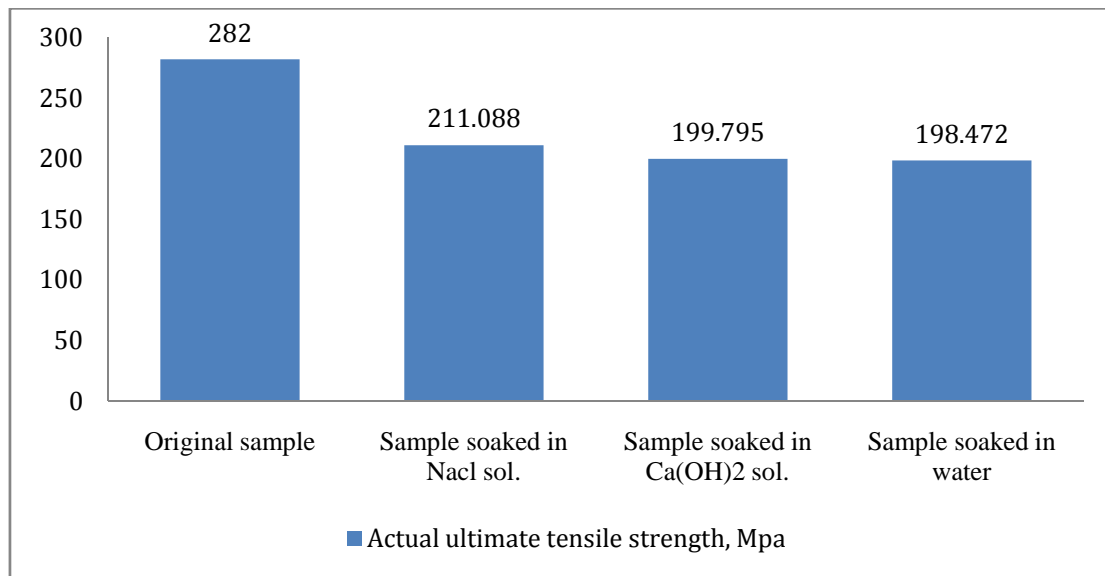
Figure 7: Chart comparing actual ultimate tensile strength after subjecting the specimens to alternate wetting & drying.

Charts comparing ultimate tensile strength and percentage loss of ultimate tensile strength after subjecting the bamboo splints specimens to alternate wetting and drying in differ environments were plotted and shown in Figure 7.

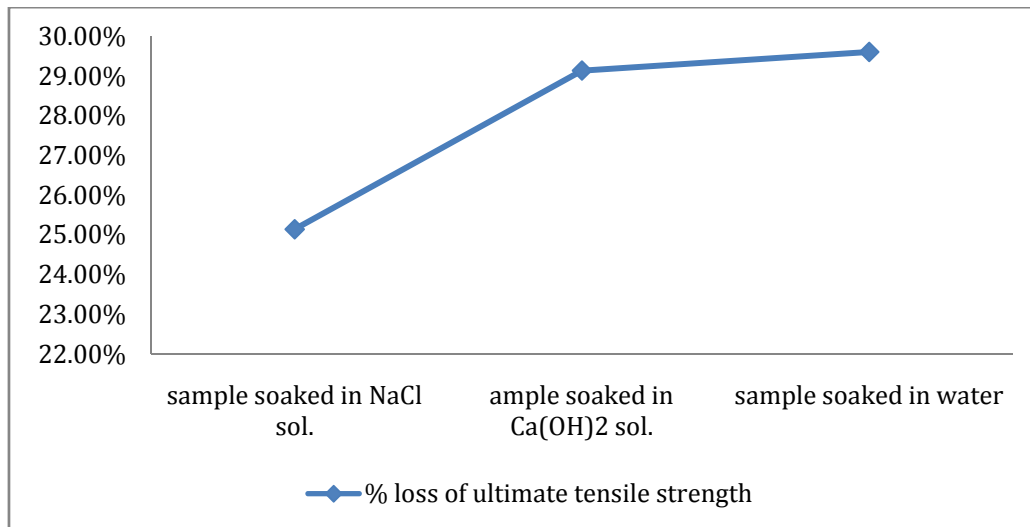
Figure 8: Chart comparing percentage loss of ultimate tensile strength after subjecting the specimens to alternate wetting & drying.

Highest loss of ultimate tensile strength of about 29.61% was observed in bamboo splints samples that were soaked in plain water followed by 29.14% in that soaked in Ca(OH)₂ solution and minimum of 25.14% in that soaked in NaCl solution. This is shown in Figure 8.

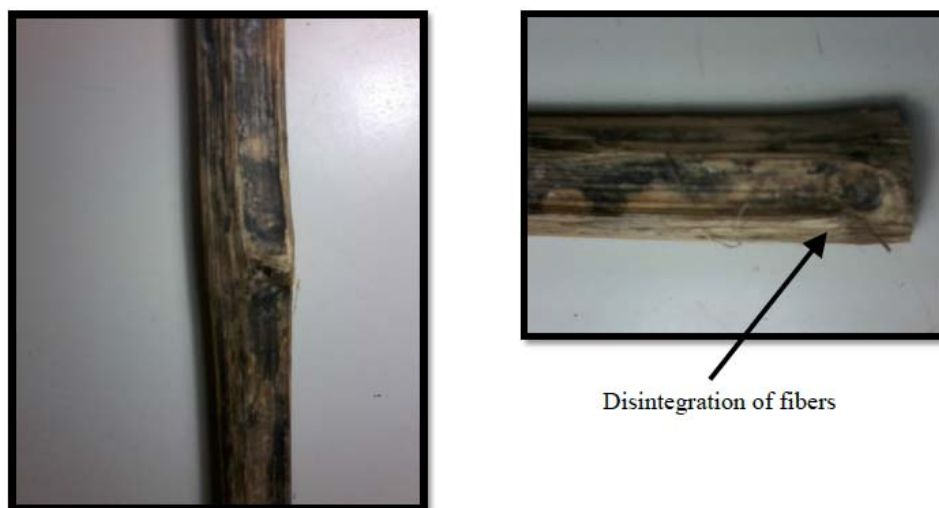
Figure 9: showing heavy fungal attack on the surface of one of the bamboo splint (W-1), soaked in water, causing rotting of bamboo & disintegration of fibers

Heavy fungal attack was observed on the surface of one of the bamboo splint (W-1), soaked in plain water, causing rotting of bamboo & disintegration of fibers. This has been illustrated in figure 9.

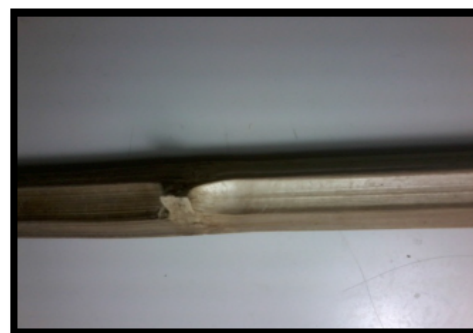
Figure 11: shows that no fungal attack was observed on the bamboo splints which were wetted in NaCl Solution, neither at nodes nor at the inner surface.

Minor fungal attack was observed on the bamboo splints which were wetted in Ca(OH)₂ solution at nodes; though the attack did not caused any disintegration of fibre or rotting of bamboo. In addition to fungal attack deposition of calcium took place on the bamboo surface. This is shown in Figure 10. No fungal attack was observed on any of the bamboo splint which was wetted in NaCl Solution, neither at nodes nor at the inner surface. This is shown in Figure 11.

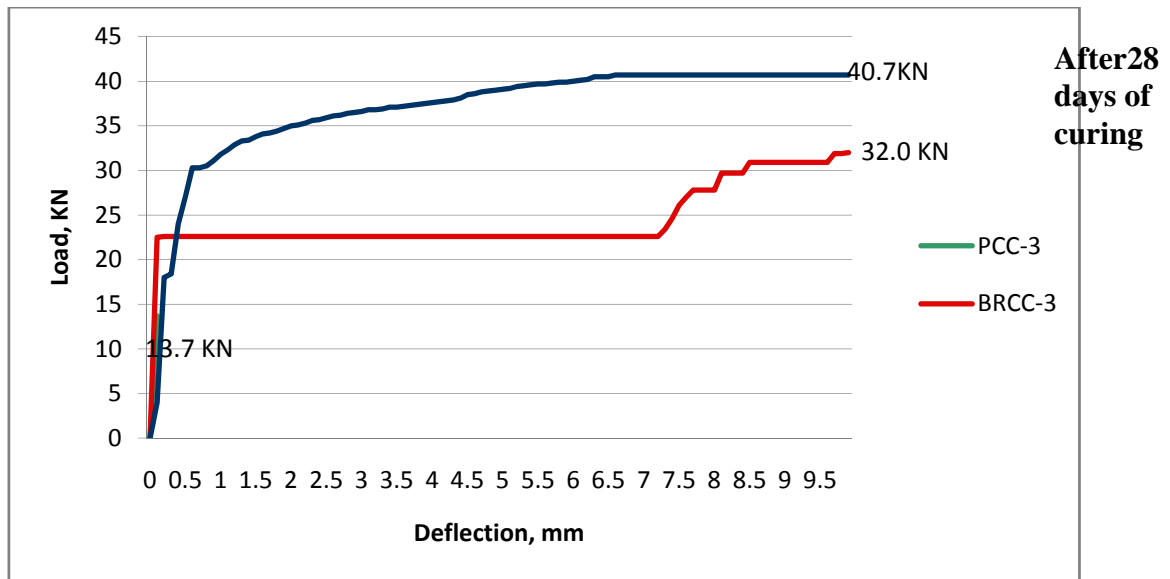
Figure 12: Load-vs.-deflection curves of plain and doubly reinforced cement concrete beam specimens after (a) 7, (b) 14 and (c) 28 days of curing respectively.

Figure 12 displays the Load-vs.-deflection curve of each of the specimen tested (for 7, 14 and 28 days respectively) which show that curves follow a straight line variation until the appearance of first crack in concrete. Immediately following the first crack there was flattening of the deflection curve (may be due to local bond slippage), followed by another fairly straight line variation but with a decrease slope, until ultimate failure of member occurs.

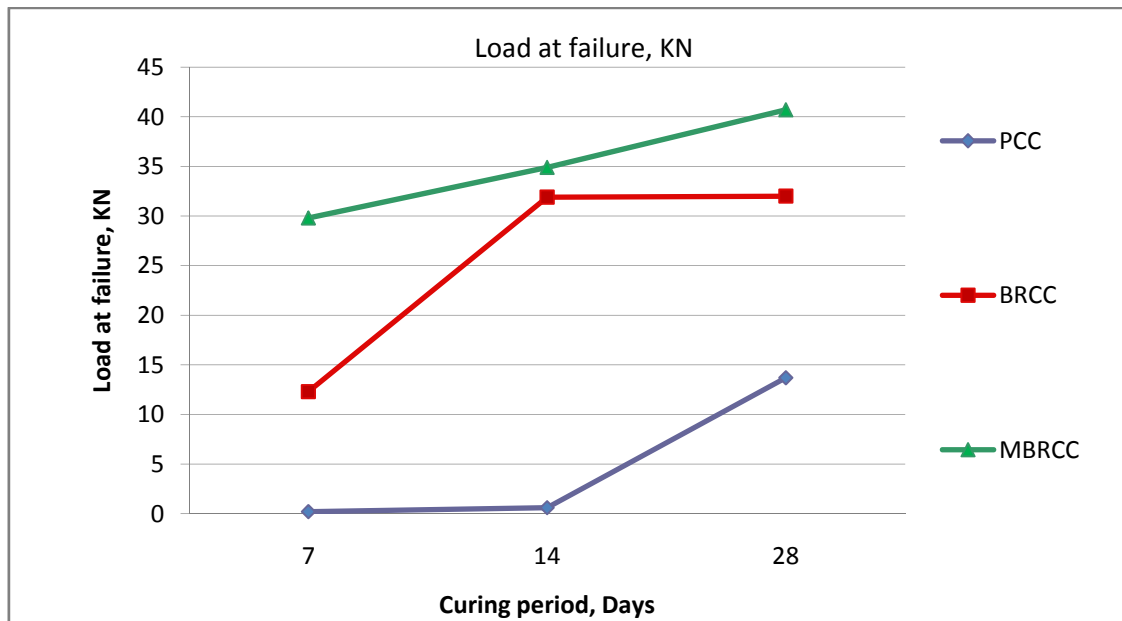
Figure 13: Graphical Representation of load at failure of plain and doubly reinforced beams.

The load carrying capacity of cement-concrete beams increased by 2.3 times when doubly reinforced with Non-treated Bamboo splints, and by 2.9 times when doubly reinforced with Treated Bamboo splints, after 28 days of curing respectively. This is shown in Figure 13. The Modulus of rupture of cement-concrete beams increased by 2.3 times when doubly reinforced with Non-treated Bamboo splints, and by 2.7 times when doubly reinforced with Treated Bamboo splints, after 28 days of curing respectively. This is shown in Figure 14.

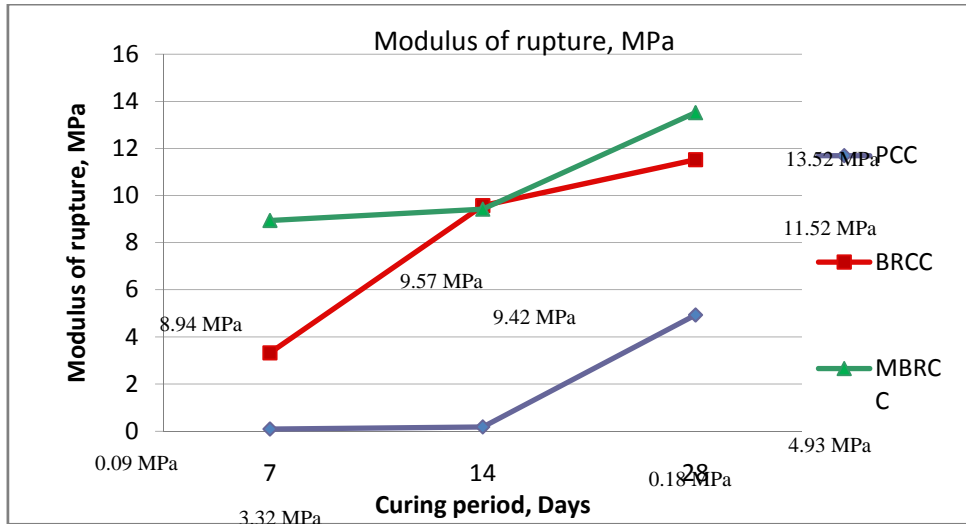
Figure 14: Graphical representation of comparing modulus of rupture of plain and doubly reinforced beams.

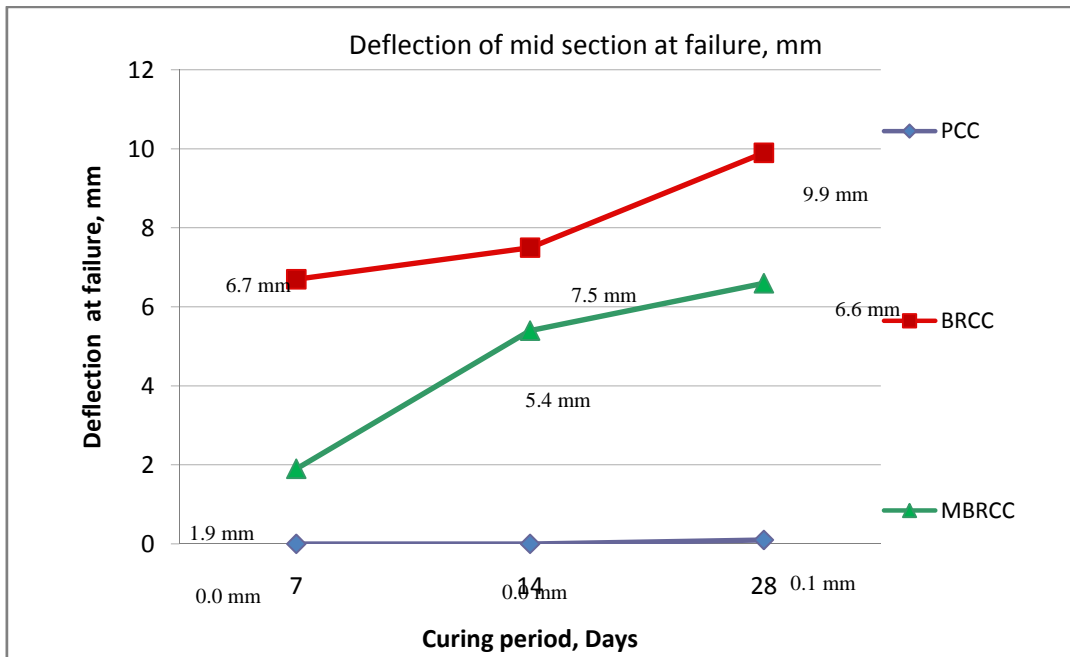
Figure 15: Chart comparing deflection of mid section at failure of plain and doubly reinforced beams.

Deflection of mid-section up to 9.9mm was observed in the beams reinforced with Non-Treated bamboo splints, and up to 6.6mm was observed in the beams reinforced with Treated bamboo splints before ultimate failure, hence reinforcing concrete beams with bamboo splints imparted sufficient ductility to the beams preventing sudden brittle failure at ultimate loads. This is observed from Figure 15.

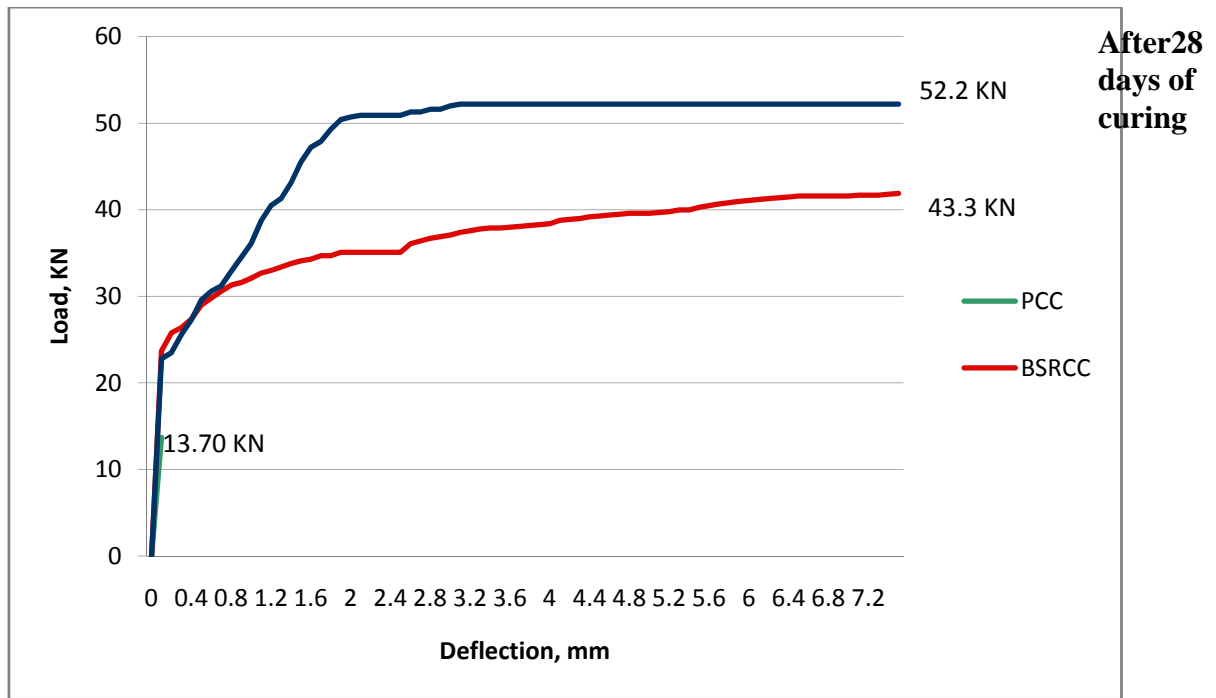
Figure 18: Load-vs.-deflection curves of plain and singly reinforced cement concrete beam specimens after 28 days of curing.

Figure 18 displays the Load-deflection curve of each of the specimen tested which shows that Load-deflection curves followed straight line variation until the appearance of first crack in concrete. Immediately following the first crack there was fluttering of the deflection curve (may be due to local bond slippage), followed by another fairly straight line variation but with a decrease slope, till ultimate failure of member occurred.

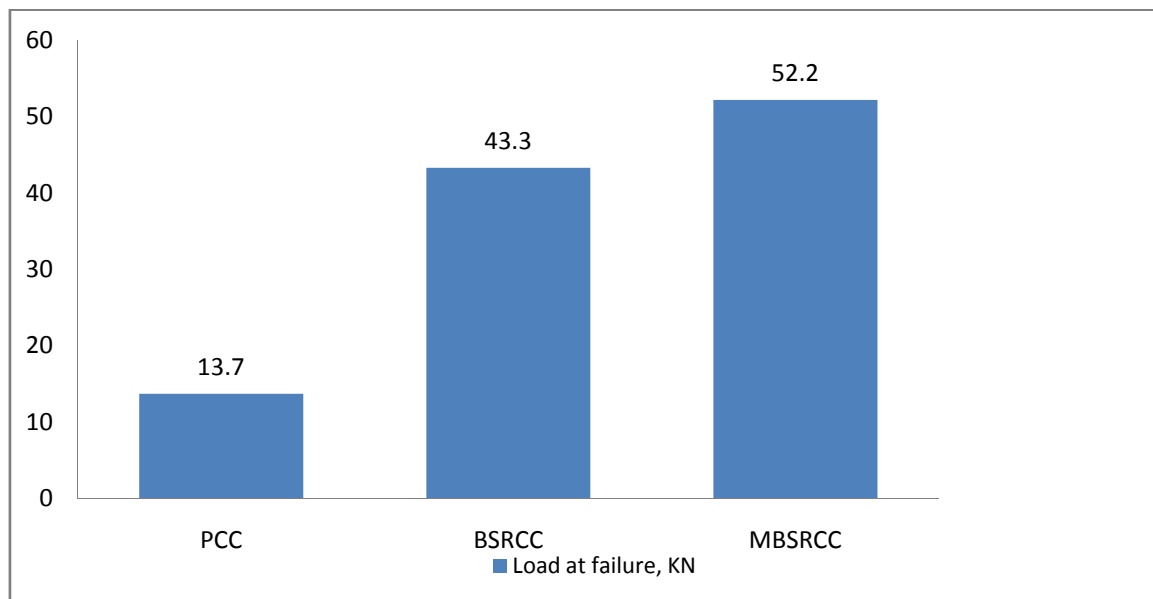
Figure 19: Bar Chart comparing load at failure of plain and singly reinforced beams.

The load carrying capacity of cement-concrete beams increased by 3.16 times when singly reinforced with Non-treated Bamboo splints, and by 3.81 times when singly reinforced with Treated Bamboo splints, after 28 days of curing respectively. This is shown in Figure 19

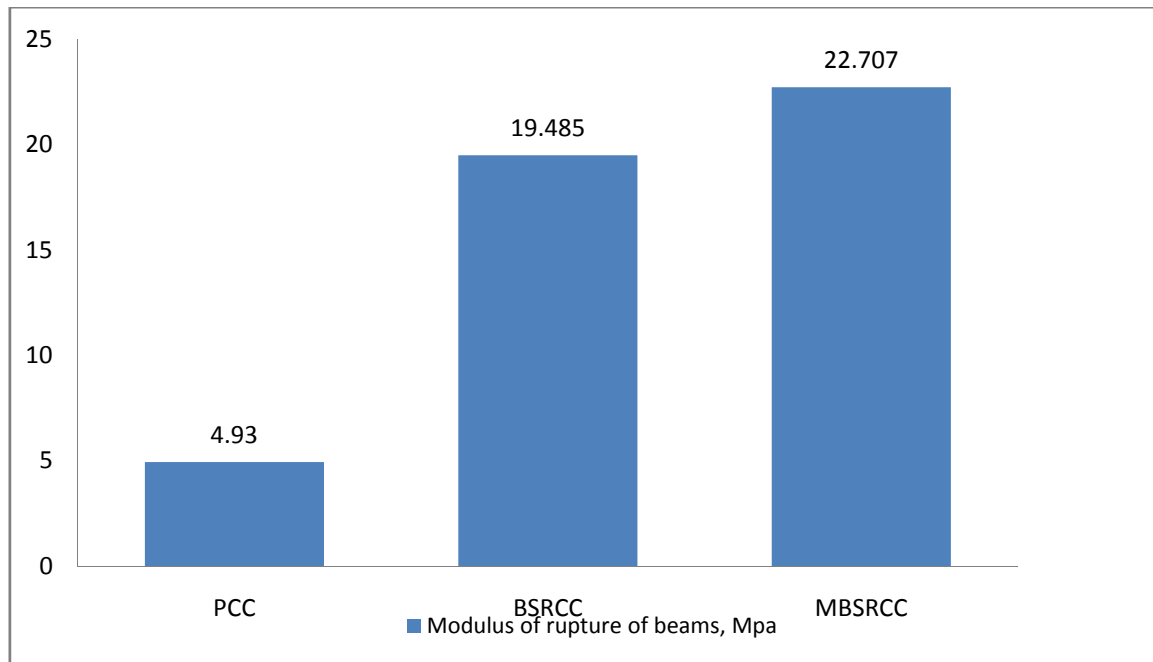
Figure 20: Bar Chart comparing modulus of rupture of plain and singly reinforced beams.

The Modulus of rupture of cement-concrete beams increased by 3.95 times when singly reinforced with Non-treated Bamboo splints, and by 4.60 times when singly reinforced with Treated Bamboo splints, after 28 days of curing respectively as shown in Figure 20.

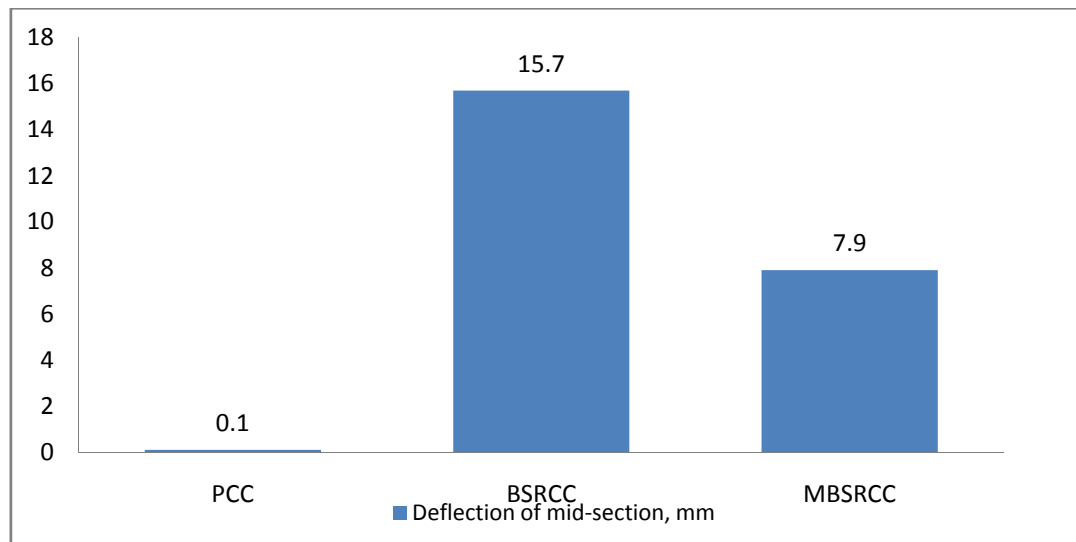
Figure 21: Chart comparing deflection of mid section at failure of plain and singly reinforced beams.

Deflection of mid-section up to 15.70 mm was observed in the beams singly reinforced with Non-Treated bamboo splints, and up to 7.90 mm was observed in the beams singly reinforced with Treated bamboo splints before ultimate failure, hence reinforcing concrete beams with bamboo splints imparted sufficient ductility to the beams preventing sudden brittle failure at ultimate loads. This is observed from Figure 21.

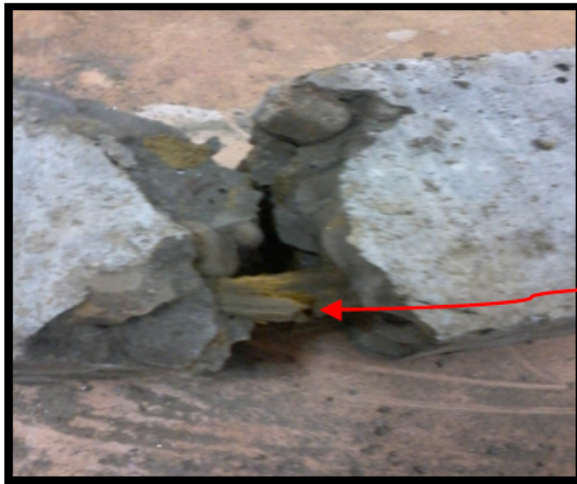
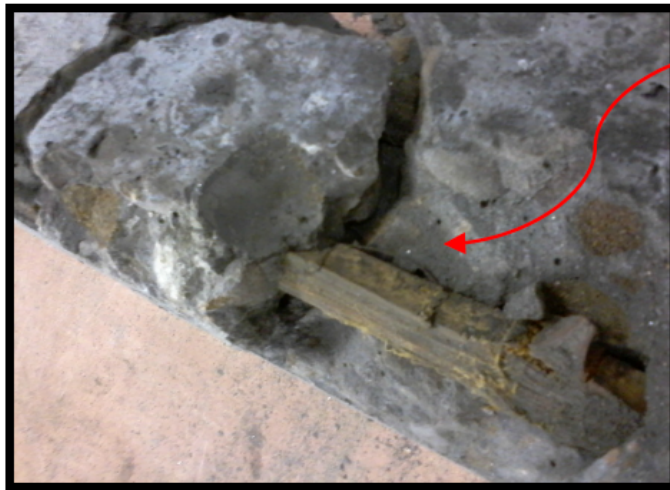
Figure 22: Behaviour of BSRCC beams

Splitting of tensile reinforcement at node, indicates ductile failure of beam-BSRCC:3

Making grooves on the inner surface of bamboo splint helped in maintaining the structural integrity and enhanced the concrete-bamboo bond to a fair amount.

Figure 22 shows the behaviour of BSRCC beam under loading and Figure 23 shows the behaviour of MBSRCC beam under loading.

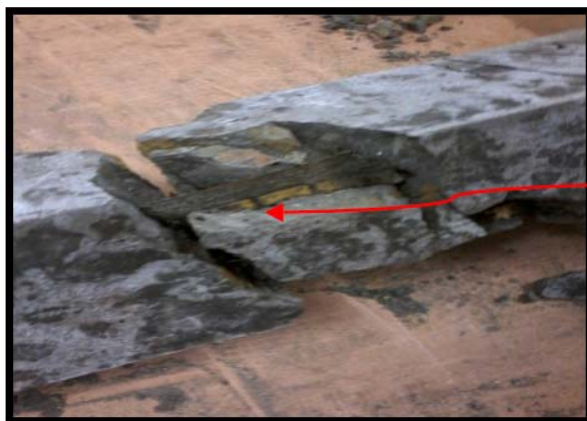
Figure 23: Behaviour of MBSRCC beams

In case of MBRCC beams the grooves got filled up by Bitumen + Sand mixture making them ineffective in enhancing the concrete bamboo bond resulting in poor transfer of stresses between the two, because of this, splitting of bamboo did not occurred in any of the MBRCC beams.

In case of MBSRCC beams the grooves got filled up by Bitumen + Sand mixture making them ineffective in enhancing the concrete bamboo bond resulting in poor transfer of stresses between the two, because of this, splitting of bamboo did not occurred in any of the MBSRCC beams.
